## ROCK MASS QUALITY EFFECTED BY LINEAMENT USING ROCK MASS RATING (RMR) CASE STUDY FROM FORMER QUARRY SITE

Hamzah Hussin<sup>1,2\*</sup>, Nurhazren bt Fauzi<sup>1</sup>, Tajul Anuar Jamaluddin<sup>2</sup> and Mohd Hariri Arifin<sup>2</sup>

### ABSTRACT

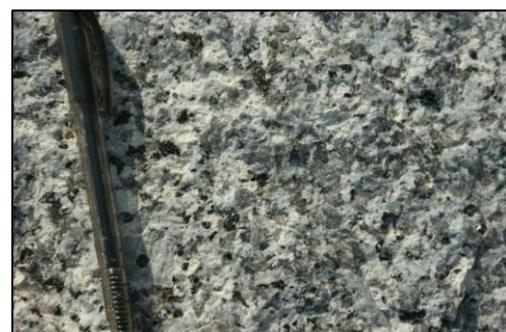
**Figure 1:** Close-up view of the fresh granite.

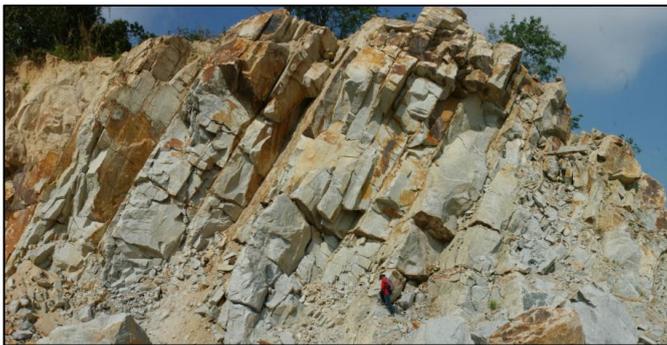
The exposed rock masses vary in weathering grade from fresh (grade I) to slightly weathered (grade II), moderately weathered (grade III) and highly weathered (grade IV) rocks. The fresh and slightly weathered rocks are generally exposed at the lower section of the rock cuts, while the moderately and highly weathered rock masses are exposed in the middle and upper sections of the slope (Figure 2). In general, the completely weathered (grade V) rocks and the residual soils (grade VI) layers on the quarry floor have been excavated and removed by past rock quarrying activities. The granite is well jointed and in places is dissected by fault and shear zone. In the studied slopes, discontinuities in the rock mass are mainly found in the form of joints and some localized faults and shear zones (Figures 2). The discontinuity can be found both in fresh rock and highly to completely weathered rocks. Relict discontinuities in the highly weathered rocks can found in almost all slopes.

**Figure 2:** Heavily jointed granite which control potential mode of failure to occur, either in wedge, planar or toppling.

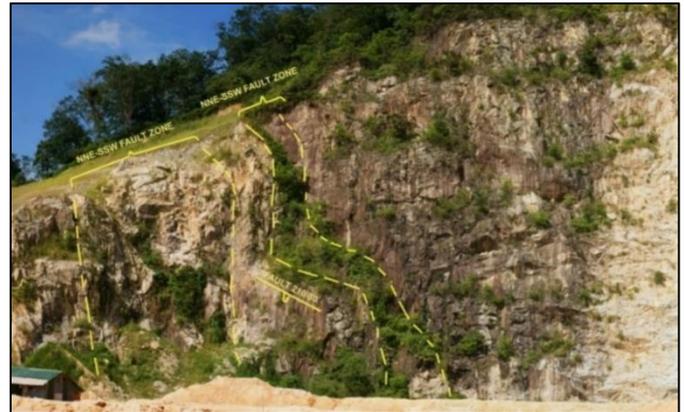
**Figure 4:** View part of the fracture (fault) zone which represents the major NNE-oriented lineaments that cut through the rock slope at the boundary between Domain C and D.

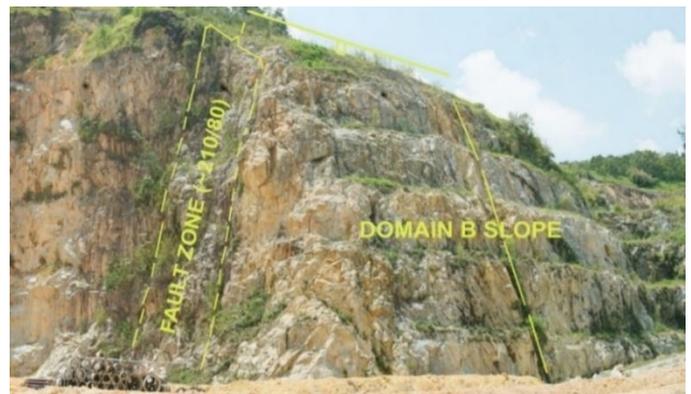
In Domain D slope, the major NNE-SSW lineament is characterized by series of subvertical and relatively sharp fault planes that controlled the slope faces. In Domain B slope, the NNW-SSE lineament is also found to be represented by a major fault zone of about 2-3 wide, striking roughly 210/80W. Along this zone, the rock mass is heavily fractured and intensely jointed (Figure 5).

**Figure 5:** Part of Domain B slope that has been affected by the NNE-SSW lineament which is characterized by a fault zone with intensely fractured rock mass.

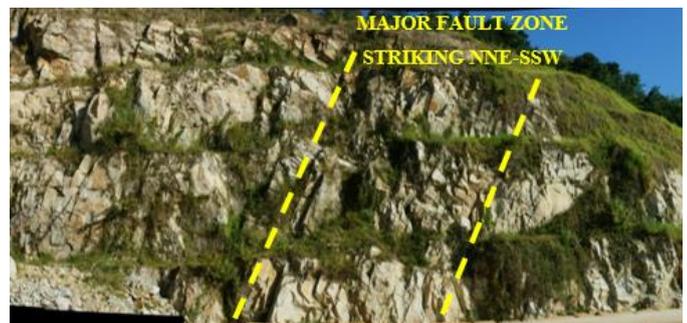
Domain A Slope is also partly affected by the major NNE-SSW lineament/fault zone. In the slope, the fault zone is marked by a zone of intensely jointed/fractured rock mass, extending about 20m wide, right from the bottom to the top of the slope. Whereas the right and left counterparts, the rock mass is relatively less fractured/jointed (Figure 6).

**Figure 6:** Note the occurrence of heavily jointed/fractured zone (about 15m wide) in Domain A rock slope.

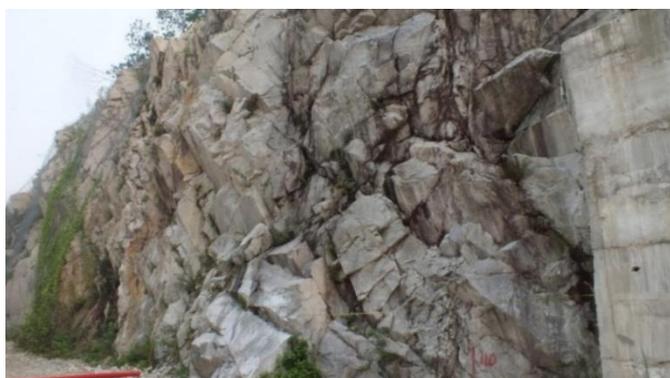
**Figure 8:** Nature of slope effected by lineament in the Kajang Granite Quarry. The slope is highly fracture with 5 sets of discontinuities.

Besides that, the result obtained from the affected lineament for Slope C, at Goodview Height also was classified the rock mass in 'Poor rock' which the value of Rock Mass Rating (RMR) was 40. This slope generally had five discontinuity sets and the orientation of discontinuities had the potential to show the slope failure modes in toppling, wedge and planar. The low rating value obtained from the characteristic of discontinuities such as medium-high of discontinuity length, extreme narrow separations, and cemented infilling of the discontinuities. Hence, the remedial works or stabilization slopes would be more difficult because these were involved a lot of unstable rock blocks.
