## ROCK MASS QUALITY EFFECTED BY LINEAMENT USING ROCK MASS RATING (RMR) CASE STUDY FROM FORMER QUARRY SITE

Hamzah Hussin<sup>1,2\*</sup>, Nurhazren bt Fauzi<sup>1</sup>, Tajul Anuar Jamaluddin<sup>2</sup> and Mohd Hariri Arifin<sup>2</sup>

### ABSTRACT

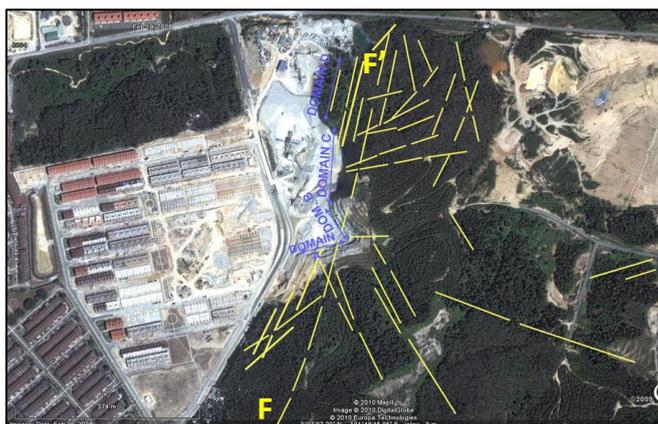
The major lineaments at Palm Walk is shown in Figure 3. In the field their occurrences are often characterized by fault slivers or zones of heavily fractured rock that are oriented in the same direction or running parallel to the identified lineaments. In this case study, the rock slopes are dissected predominantly by the NNE-SSW oriented lineaments, and these have been verified in the field by the occurrences of fault zone striking in NNE/SSW and dip almost subvertical (80°) to the E or W (Figure 4).

**Figure 3:** Photolineaments in the granite bedrock of the Palm Walk. Note that the slopes are dissected by major NNE oriented lineaments (F-F').

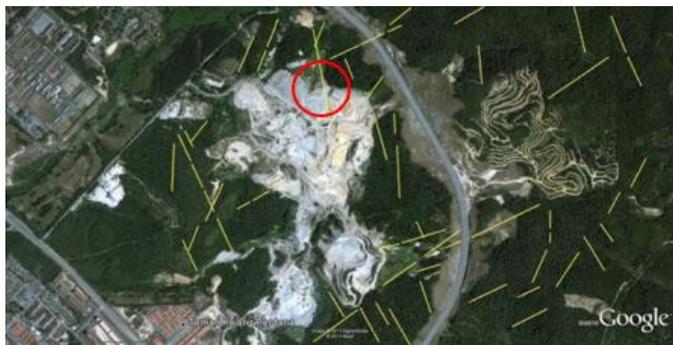
suggests that the area is dissected by at least 4 sets of lineaments, mainly strike in NW-SE, almost N-S, NE-SW and ENE-WSW direction. The slope effected by lineament was located at northern part of study area. The existing of lineament was clearly seen at slope with the heavily jointed/fractured zone characteristics (Figure 8). The orientation of lineament is subvertical and the discontinuities persistence was high and its width was 15m.

**Figure 7:** Photolineaments in the vicinity of the study area as interpreted from satellite image of Google Earth. The circle shown present of lineament and its view is shown in Figure 11.

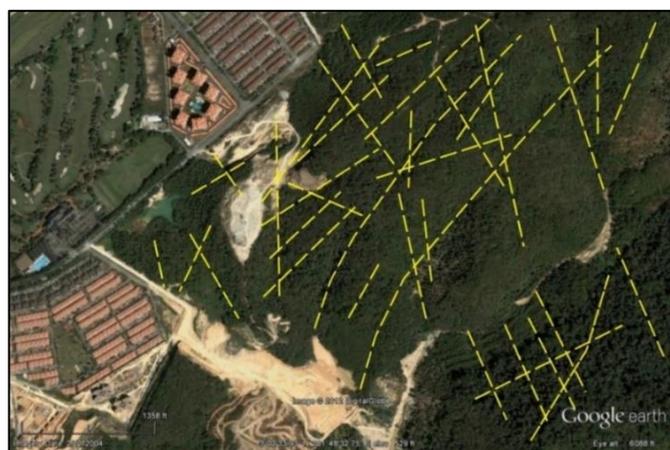
**Figure 9:** Lineament interpretation from a satellite image (Google Earth, 2004) of the study area.

Result of the photolineament study suggests that the area is dissected by at least 4 sets of lineaments, mainly strike in N-S, NE-SW, NW-SE, and SSE-NNW directions. Most dominant lineaments are oriented in NW-SE and NE-SW direction. Major lineament oriented SSE-NNW can be found in slope face and can be classified as fault zone. This fault zone is

characterized by sudden change of the slope-forming material from hard rock in the right to soil-like material on the left.

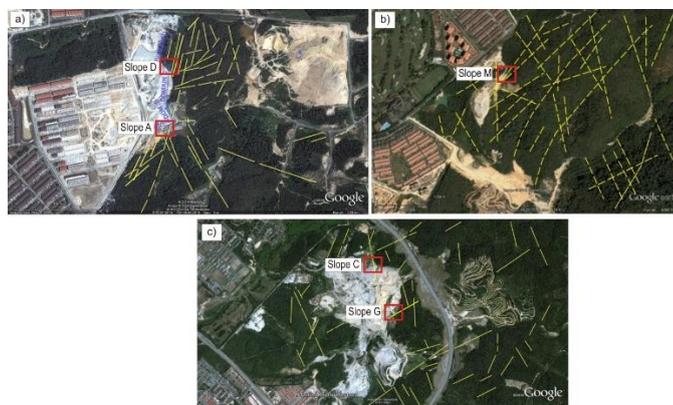
Five slopes were selected for detail scan line mapping to determine its rock mass quality using rock mass classification (RMR) as shown in Figure 10. The selected slope was choose based on lineament interpretation.

**Figure 10:** Location for scan line survey at three sites were conducted at rectangular box; a) Palm Walk, b) Mayang Kiara and c) Kajang Granite Quarry
